**ARMORING OF SYNTHETIC-FIBER DEEP-SEA
MOORING LINES AGAINST FISHBITE**

Paul B. Stimson, et al

Woods Hole Oceanographic Institution

September 1972

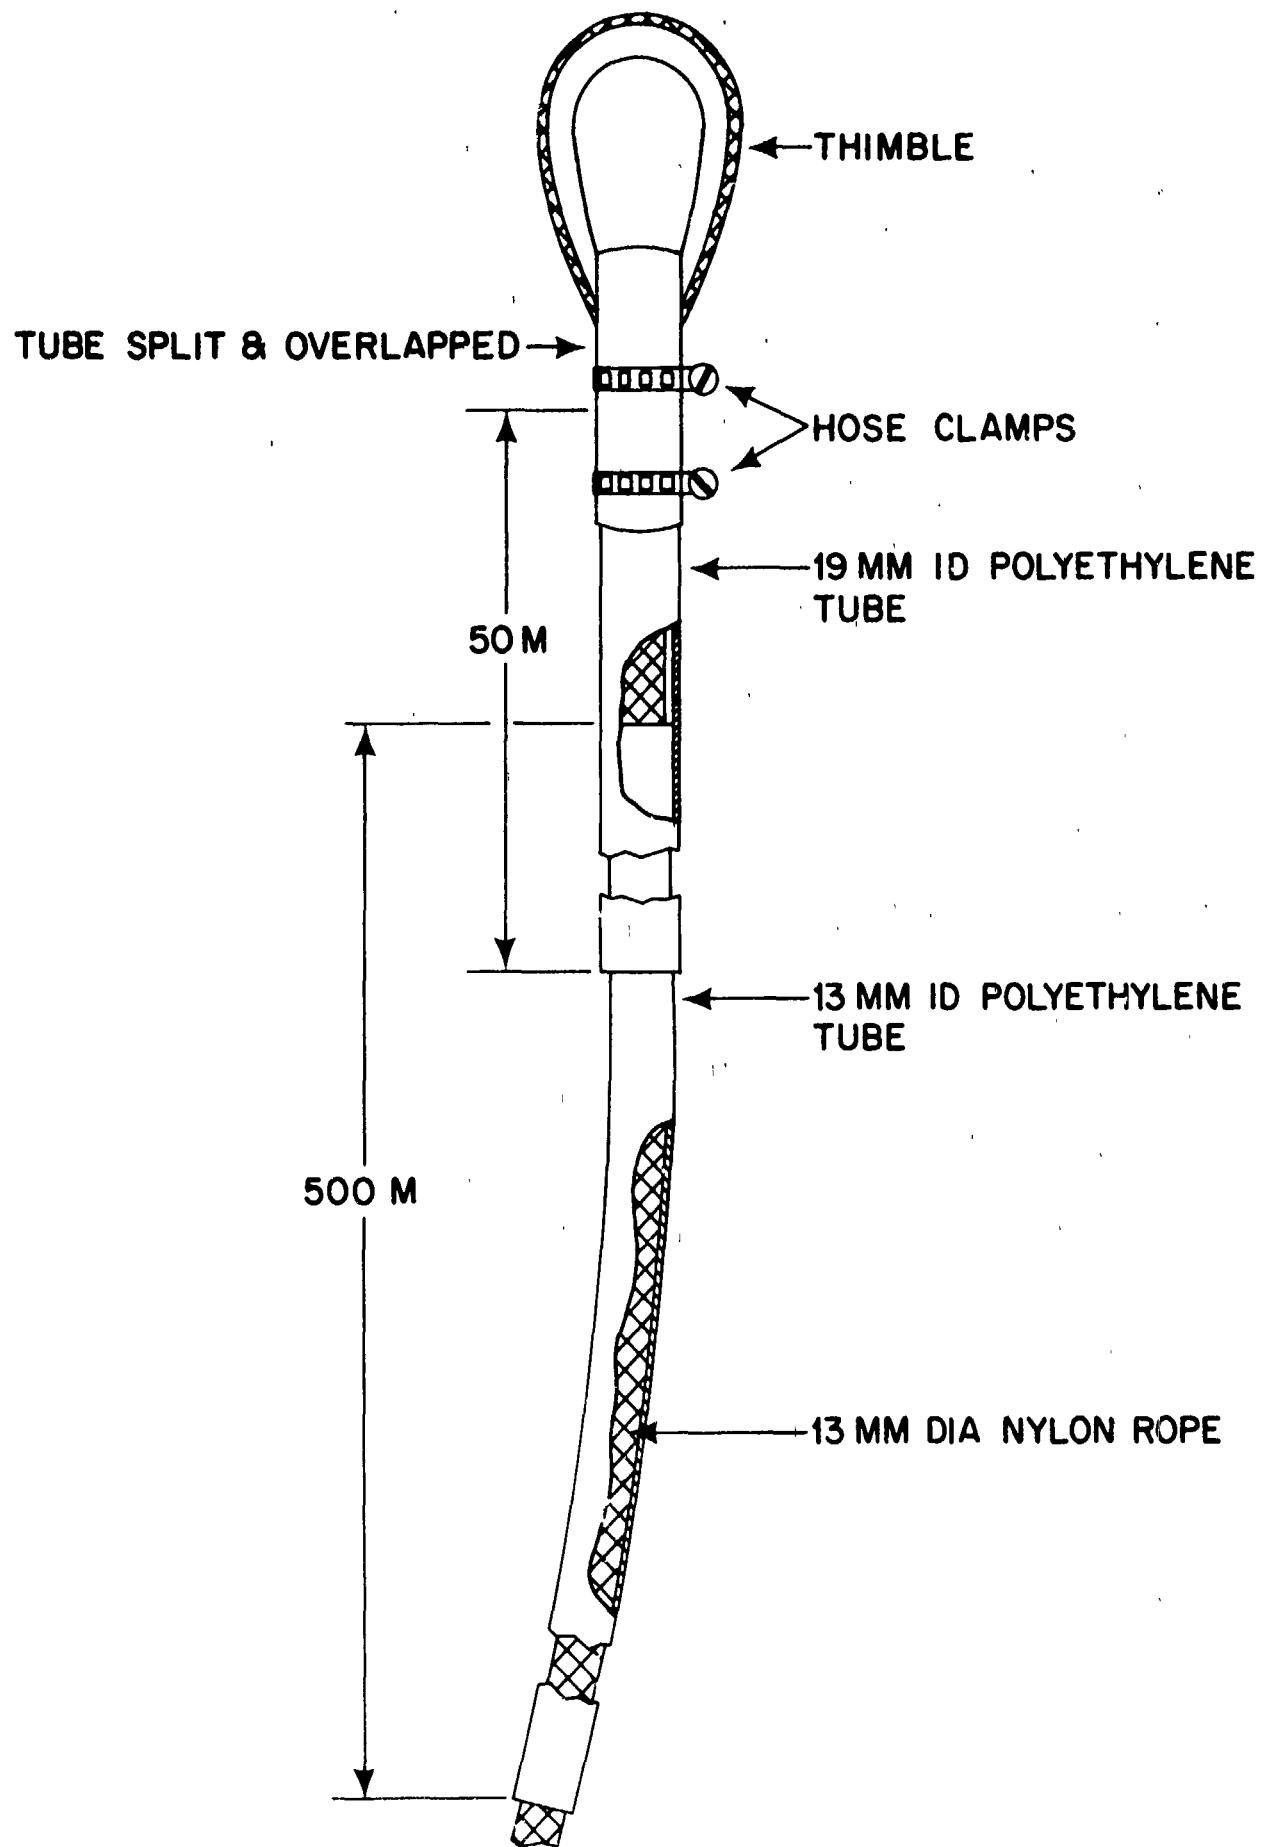
Early in the laboratory tests, it was established that resistance to cutting diminishes with increasing tensile stress in the armor. Since synthetic-fiber rope stretches appreciably under load, some means of decoupling the load from the armor is essential. If there are to be no instruments in the fishbite zone, and if the upper 2000 m of the mooring line can be manufactured and deployed in one piece, there is no problem: the armor can be affixed to the upper terminal and left free at the bottom. For moorings which must be terminated at closer intervals, the telescoping configuration shown in Figure 4 has been designed, and has been successfully tested.

Figure 4. Mooring Line Armor-Telescoping Method.

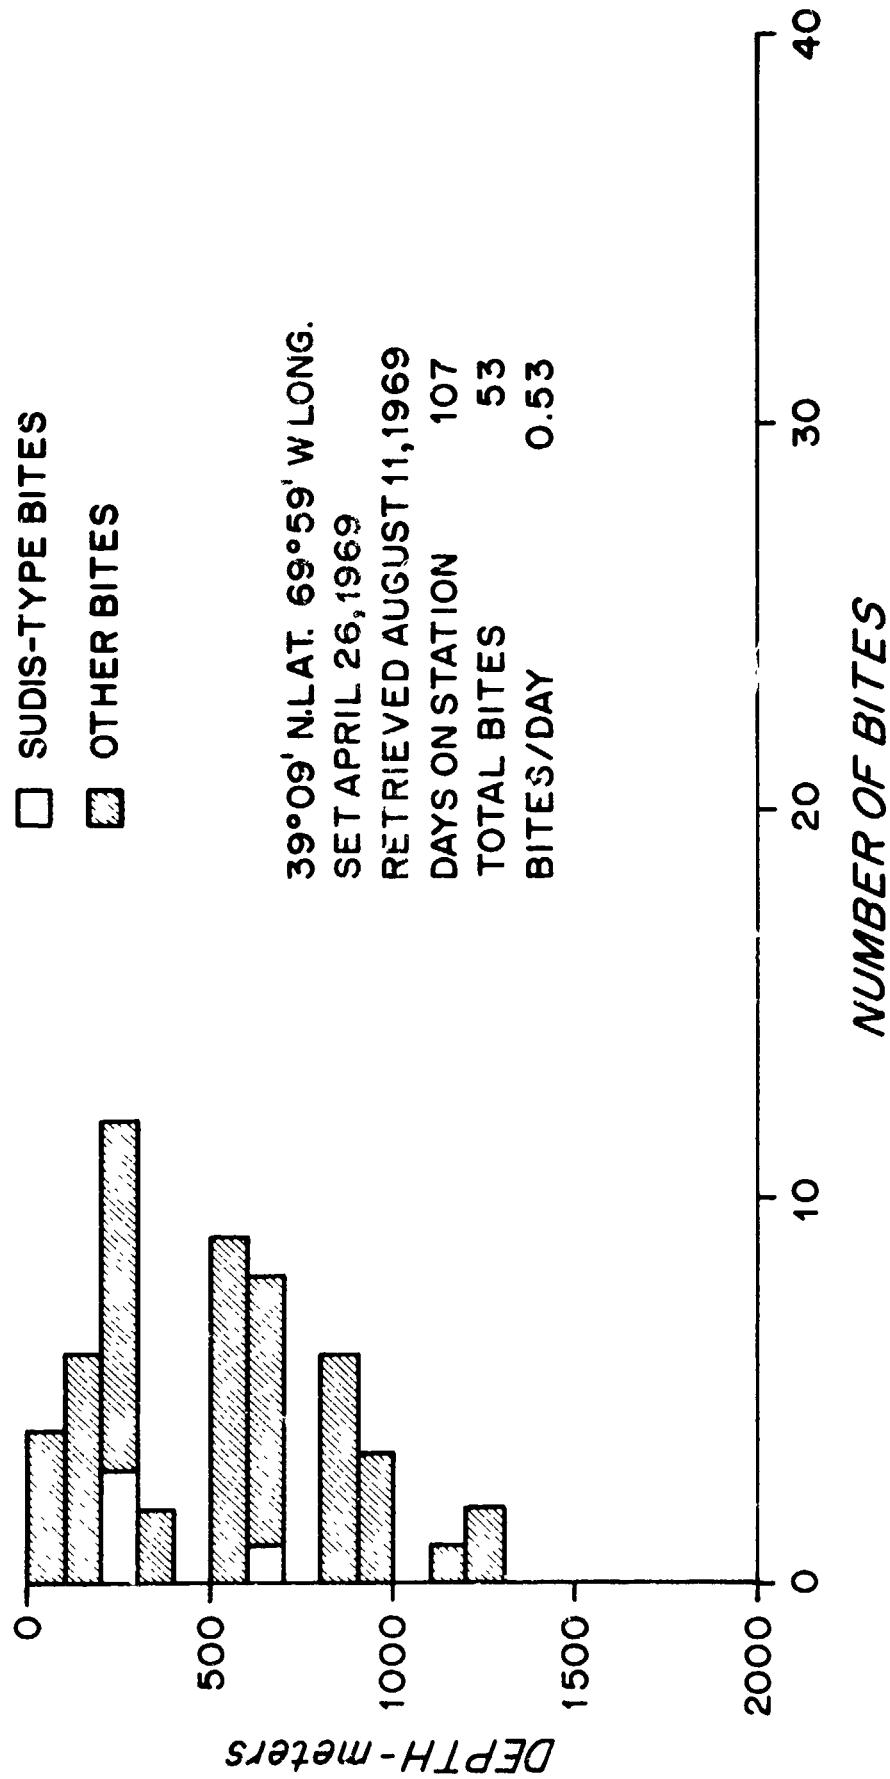
Two moored stations, #298 and #300 were set at 39° N Lat, 70° W Long (Site D). The top 1500 meters of each of these lines was steel wire rope covered with high density polyethylene. The duration of the stations and the numbers of bites observed on the retrieved lines are shown graphically in Figures 17 and 18.

An effort was made to distinguish between the type of bite previously attributed to Sudis hyalina and the more severe bites and slashes thought to be the work of sharks. Such a distinction is difficult to make and the results of the effort should not be taken too seriously. Its usefulness lies in establishing a basis for estimating the frequency of bites ("other") which are apparently caused by sharks

Figure 17. Fishbite vs. Depth
WHOI Moored Station #298

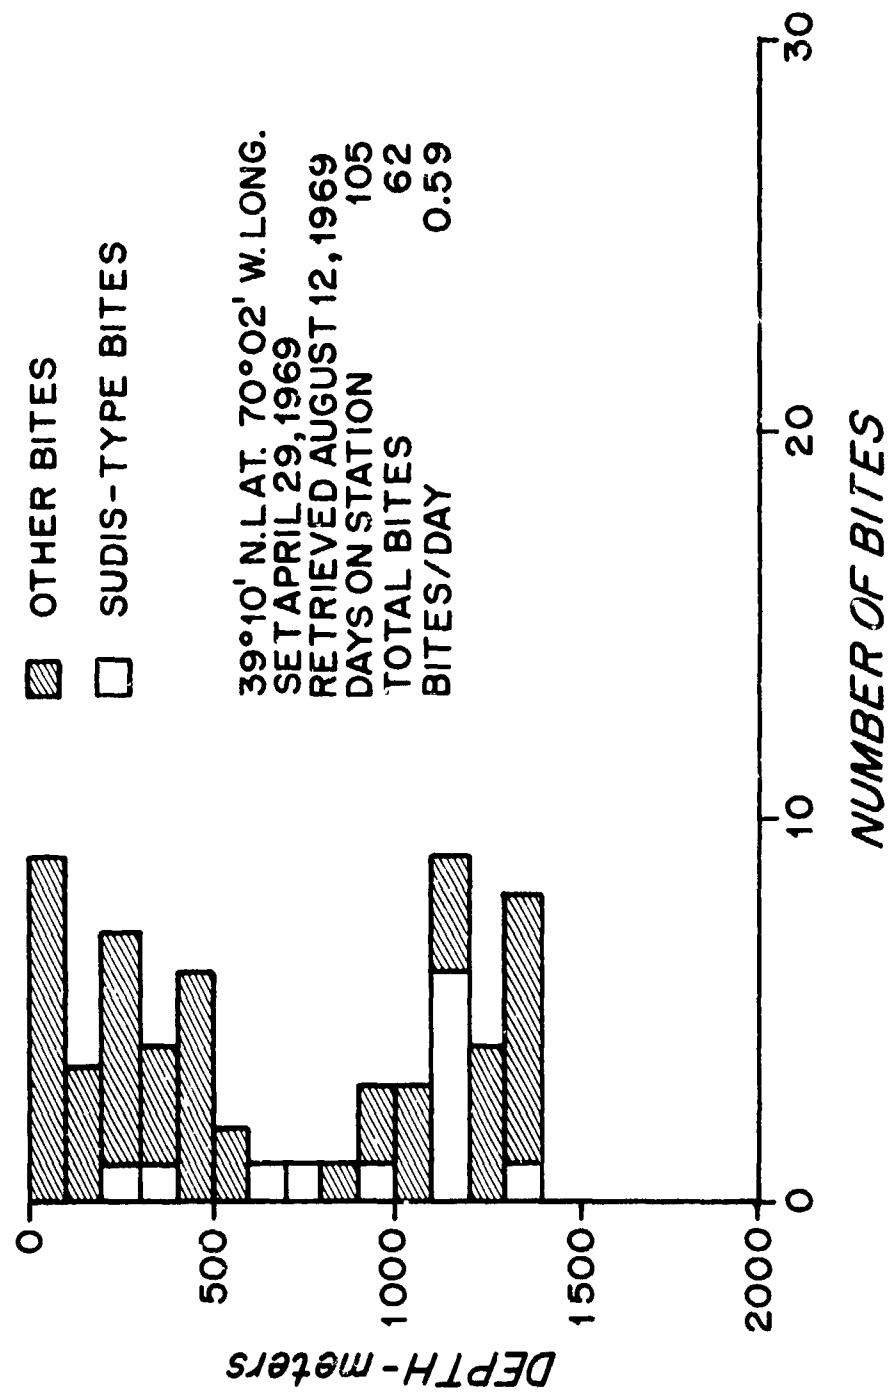
Figure 18. Fishbite vs. Depth
 WHOI Moored Station #300

and the prevention of which may be regarded as the prime target in developing protective armor. The overall average rate of such bites at the two stations was 0.47 bites per mooring line day. Most of the bites were superficial but because they are the kind attributed to sharks, a potential for serious damage is indicated. In fact, four (4) gashes in the polyethylene jacket of mooring #298 laid bare the underlying steel wire. At moored station #300, there was one such incident.

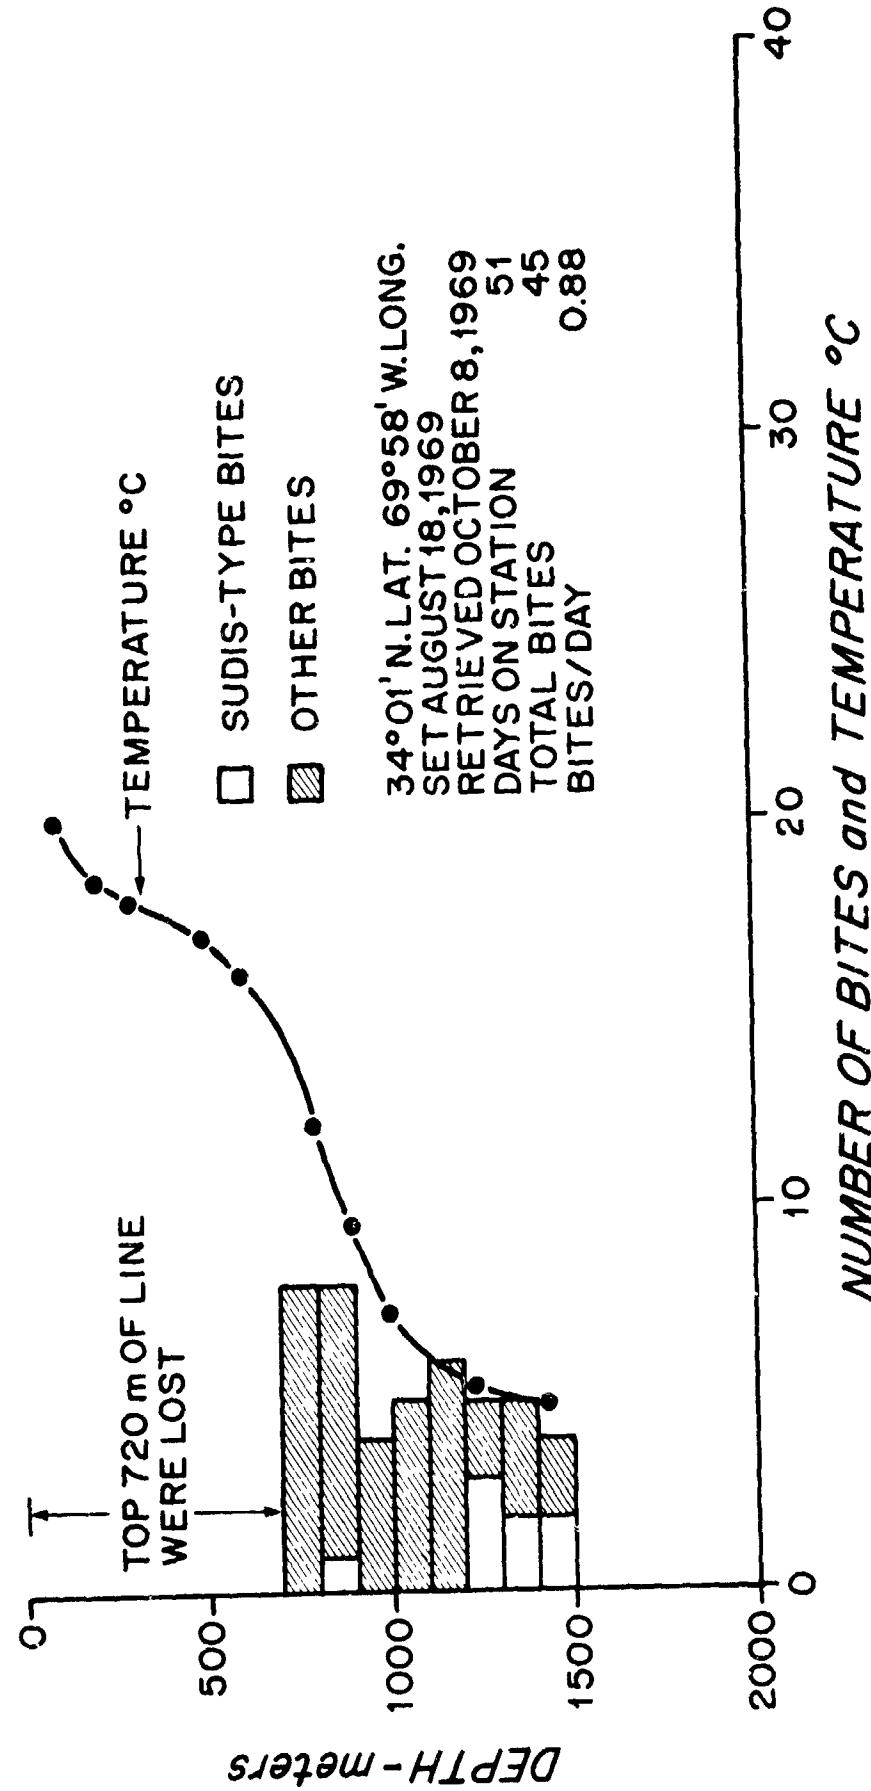
Fifty-nine bites were found on the recovered portion of the armor, all of which were below the zone of most severe attack (Figure 19). None of these penetrated the wall of the pipe, but many were severe enough to have done substantial damage to an unarmored rope. Not all of the couplings between lengths of pipe held, so the performance of the

Figure 19. Fishbite vs. Depth
WHOI Moored Station #315

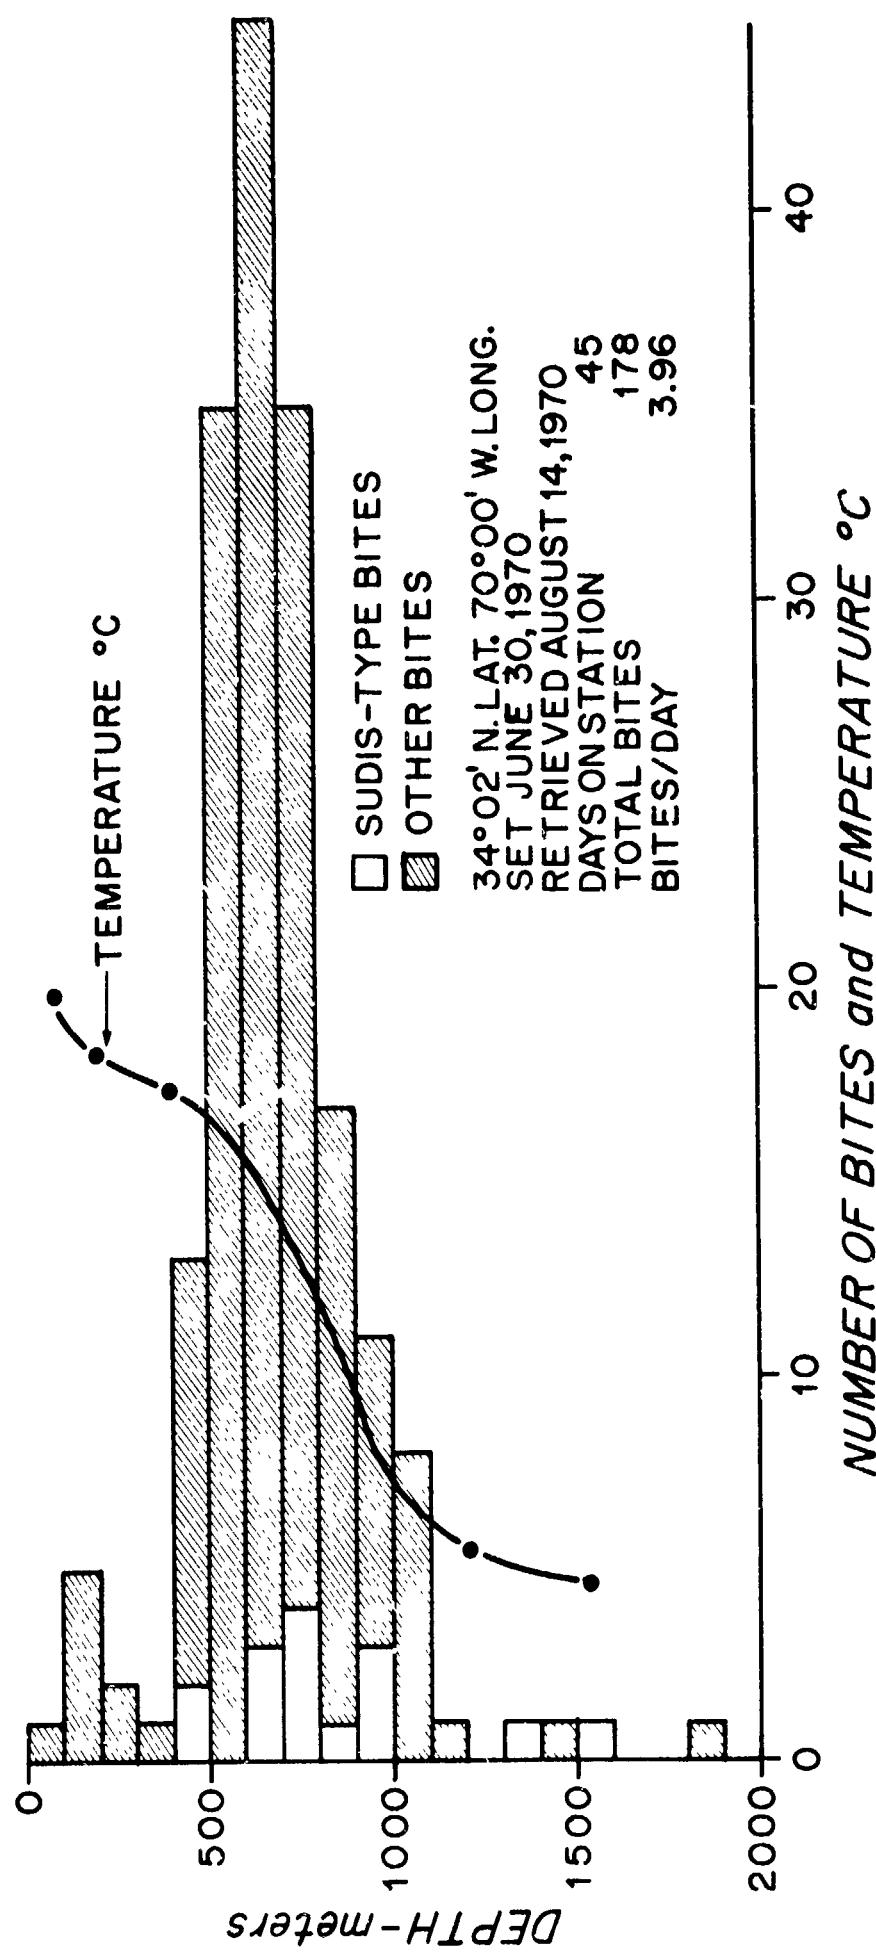
Before the mooring was launched, it was observed that a large number of fine cracks had formed on the inside wall of the polycarbonate armor. At the time of recovery two months later, the armor was severely crazed, but intact except for one break near the top of the first shot. During hauling over the sheaves and onto the winch drum it shattered into small pieces. Later, it was established in laboratory tests that crazing of the polycarbonate occurred whenever it was in close contact with the polyester rope. Presumably, some yarn treatment or lubricant is responsible. It must be isolated and eliminated before it will be feasible to use polycarbonate armor on synthetic-fiber rope.

In spite of its deteriorated condition, the polycarbonate armor withstood fishbite very well. In all, 178 bites were recorded (Figure 20). None penetrated the 1.3 mm wall.

Figure 20. Fishbite vs. Depth
WHOI Moored Station #341

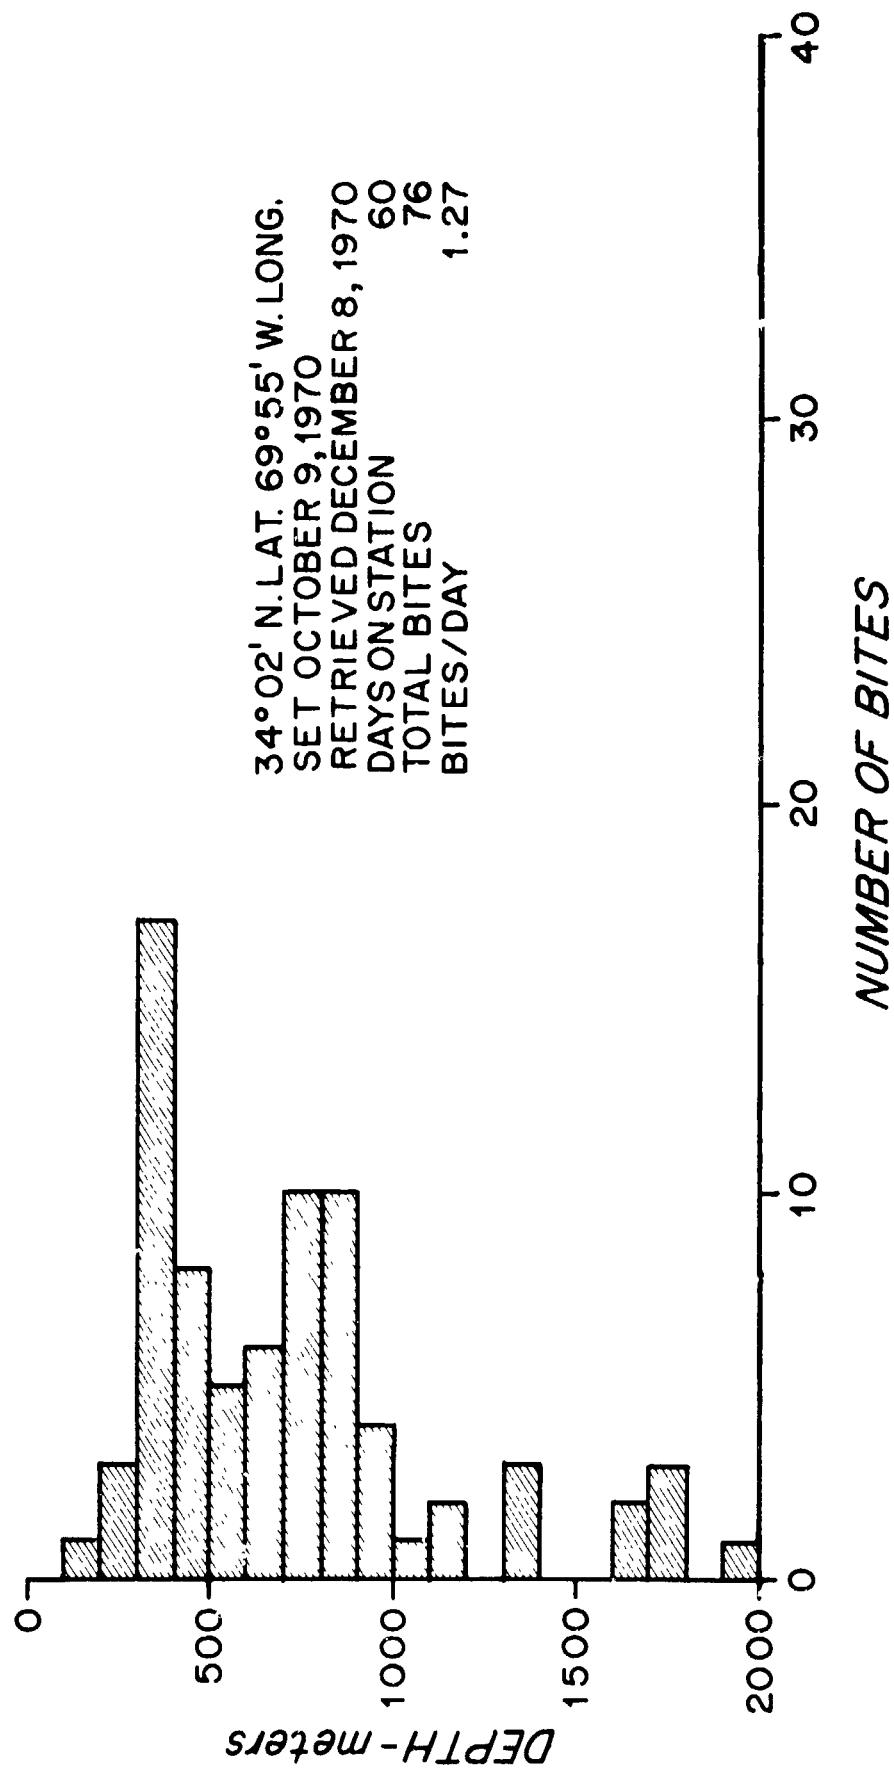
Pending a solution to the problem of polyester-polycarbonate interaction, an armor of rigid polyvinyl chloride (PVC) was specified, and four 500-m shots were installed in W.H.O.I. moored Station #355, also at Site "L" in October 1970 (Figure 21). The PVC withstood

Figure 21. Fish bite vs. Depth
WHOI Moored Station #355

fishbite, but cracked severely. The cracking appears to have been due to brittle transition at low temperature, rather than chemical interaction.
